# Access Compliance Report Public Rights-of-Way (Curb Ramps)

Main Street: WOODLAWN\_AVE Cross Street: KENNETH\_DR Location: W

ADA ID: RPRK220107123950 Ramp Type: Type 1 - Perpendicular Diagonal Initial Pass/Fail: Pass Overall Compliance: No Severity Score: 0

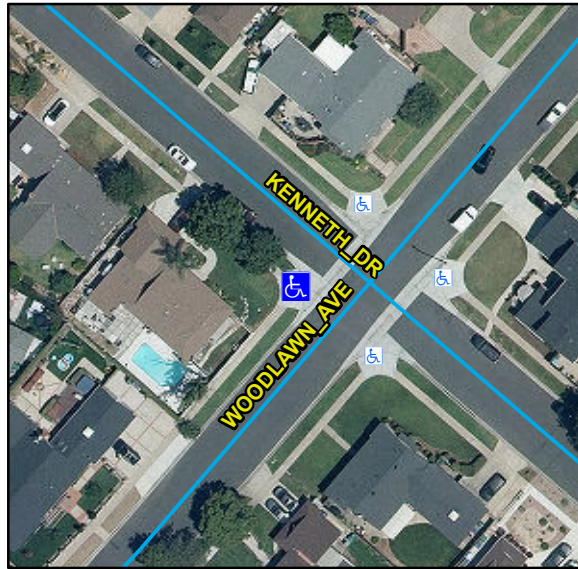
| Compliance | Description | Data | Compliance | Description | Data |
|---|---|---|---|---|---|
| N/A | Landing Movement Obstructed? | Yes | Yes | DWS Contrast | Yes |
| | Landing Movement Type | Curb | Yes | DWS Length (in) | 36 |

Remove & Replace Landing.

R304.2.1, STD 1115
