# Access Compliance Report Public Rights-of-Way (Curb Ramps)

Main Street: KENNETH\_DR Cross Street: WOODLAWN\_AVE Location: N

ADA ID: RPRK220107125003 Ramp Type: Type 1 - Perpendicular Diagonal Initial Pass/Fail: Pass Overall Compliance: No Severity Score: 6

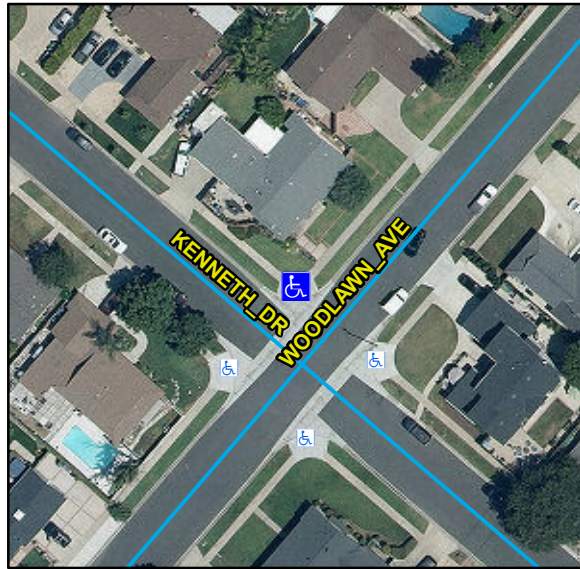
## Field Measurements/Component Compliance

Possible Solutions:

Remove & Replace Landing.

R304.2.1, STD 1115

Total Cost: \$ 531
