# Access Compliance Report Public Rights-of-Way (Curb Ramps)

Main Street: WOODLAWN\_AVE Cross Street: KENNETH\_DR Location: SE

ADA ID: RPRK220107130347 Ramp Type: Type 1 - Perpendicular Diagonal Initial Pass/Fail: Pass Overall Compliance: No Severity Score: 2

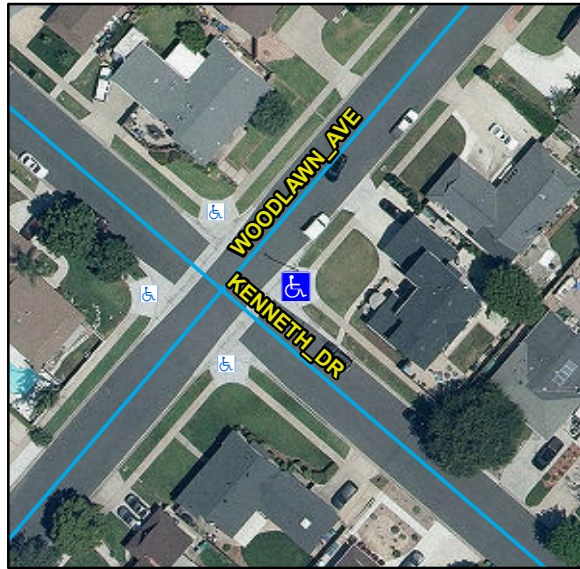
| Compliance | Description | Data | Compliance | Description | Data |
|---|---|---|---|---|---|
| N/A | Landing Movement Obstructed? | Yes | Yes | DWS Contrast | Yes |
| | Landing Movement Type | Curb | Yes | DWS Length (in) | 36 |

Possible Solutions:

Remove & Replace Landing.

R304.2.1, STD 1115
