# Access Compliance Report Public Rights-of-Way (Curb Ramps)

| Main Street: WOODLAWN_AVE | | Cross Street: LA_COLINA_DR | | Location: | E |
| ADA ID: RPRK220107131658 | Ramp Type: Type 4 - Parallel | Initial Pass/Fail: Fail | Overall Compliance: No | Severity Score: | 16 |

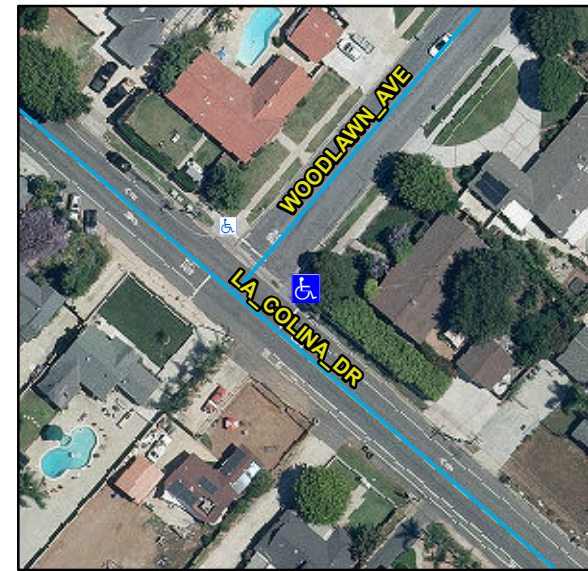
| Compliance | Description | Data | Compliance | Description | Data |
|---|---|---|---|---|---|
| No | Ramp Run Slope LT (%) | 8.4 | Yes | Ramp Run Slope RT (%) | 5.5 |
| Yes | Ramp Cross Slope LT (%) | 1.3 | No | Ramp Cross Slope RT (%) | 2.5 |

**Remove & Replace Curb Ramp With Two New Directional Ramps or Equivalent.**

**R204.3, R304.3.2, R304.5.3, STD 1115**

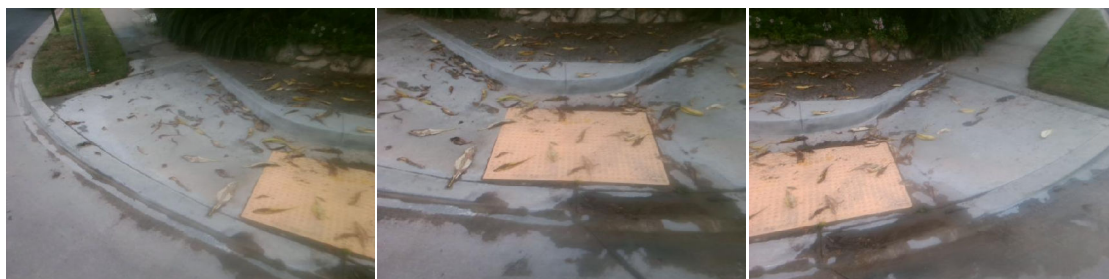
| Compliance | Description | Data | Compliance | Description | Data |
|---|---|---|---|---|---|
| N/A | Ramp Length LT (in) | 96 | N/A | Ramp Length RT (in) | 92 |
| Yes | Ramp Width LT (in) | 81 | Yes | Ramp Width RT (in) | 87 |
