# Access Compliance Report Public Rights-of-Way (Curb Ramps)

Main Street: LA\_COLINA\_DR Cross Street: WOODLAWN\_AVE Location: N

ADA ID: RPRK220107131933 Ramp Type: Type 4 - Parallel Initial Pass/Fail: Fail Overall Compliance: No Severity Score: 16

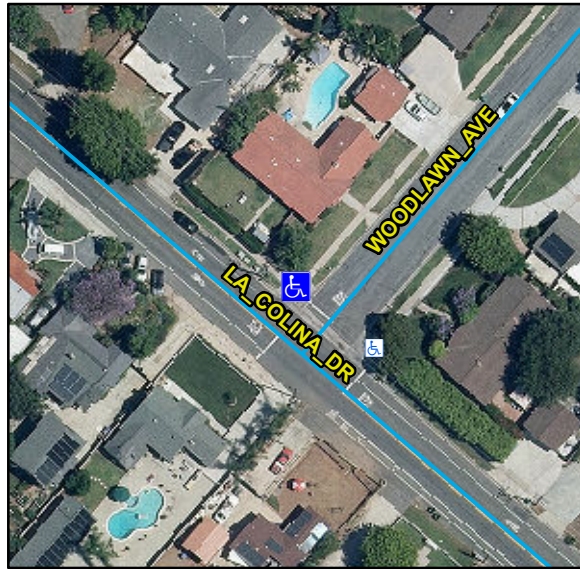
| Compliance | Description | Data | Compliance | Description | Data |
|---|---|---|---|---|---|
| Yes | Ramp Run Slope LT (%) | 6.8 | No | Ramp Run Slope RT (%) | 8.6 |
| Yes | Ramp Cross Slope LT (%) | 0.2 | No | Ramp Cross Slope RT (%) | 3.3 |

Remove & Replace Curb Ramp With Two New Directional Ramps or Equivalent.
