# Access Compliance Report Public Rights-of-Way (Curb Ramps)

Main Street: WOODLAWN\_AVE Cross Street: DEBORAH\_DR Location: W

ADA ID: RPRK220107132206 Ramp Type: Type 1 - Perpendicular Diagonal Initial Pass/Fail: Pass Overall Compliance: No Severity Score: 0

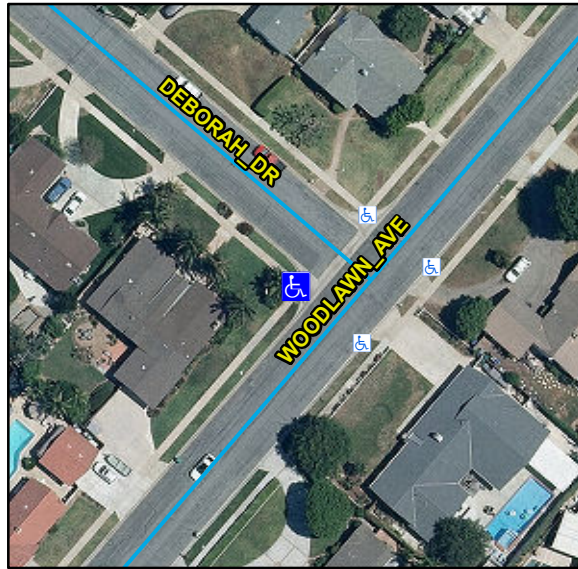
| Compliance | Description | Data | Compliance | Description | Data |
|---|---|---|---|---|---|
| N/A | Landing Movement Obstructed? | Yes | Yes | DWS Contrast | Yes |
| | Landing Movement Type | Curb | Yes | DWS Length (in) | 36 |

Possible Solutions:

Remove & Replace Landing.

R304.2.1, STD 1115

Total Cost: \$ 531
