# Access Compliance Report Public Rights-of-Way (Curb Ramps)

Main Street: DEBORAH\_DR Cross Street: WOODLAWN\_AVE Location: N

ADA ID: RPRK220107132536 Ramp Type: Type 1 - Perpendicular Diagonal Initial Pass/Fail: Pass Overall Compliance: No Severity Score: 0

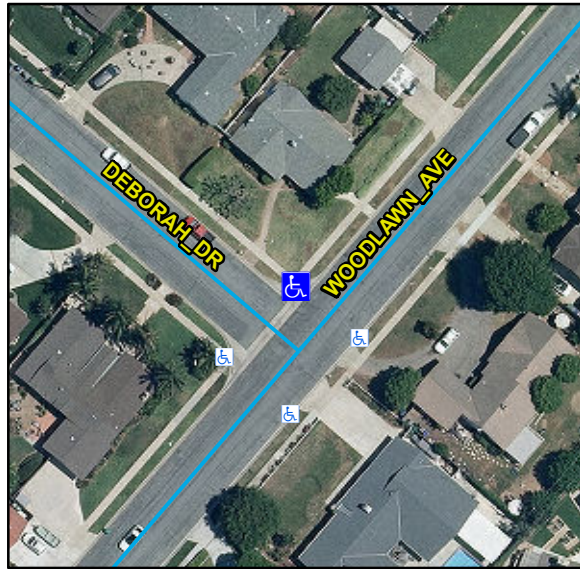
| Compliance | Description | Data | Compliance | Description | Data |
|---|---|---|---|---|---|
| N/A | Landing Present | Yes | N/A | Flare Type RT | |
| N/A | Landing Length (in) | 49 | | | Sloped |
| N/A | Landing Movement Obstructed? | Yes | Yes | DWS Contrast | Yes |
| | Landing Movement Type | Curb | Yes | DWS Length (in) | 36 |

Remove & Replace Landing.

R304.2.1, STD 1115
