# Access Compliance Report Public Rights-of-Way (Curb Ramps)

Main Street: **HOLT\_AVE** Cross Street: **IRVINE\_BLV** Location: **SW**

ADA ID: **RPRK220121114117** Ramp Type: **Type 1 - Perpendicular Diagonal Initial Pass/Fail: Pass** Overall Compliance: **No** Severity Score: **2**

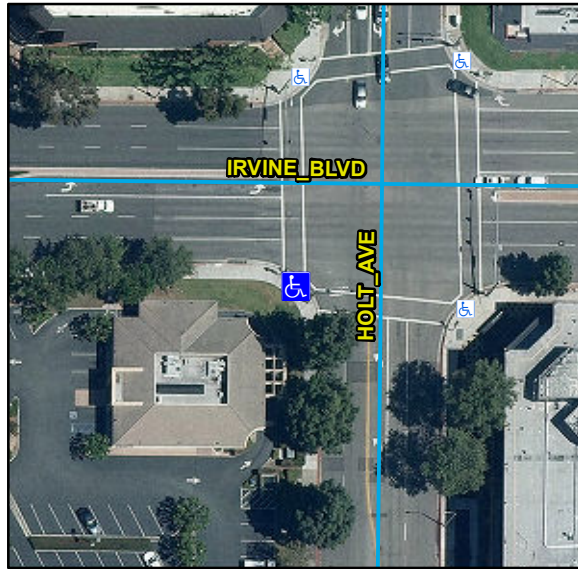
| Compliance | Description | Data | Compliance | Description | Data |
|---|---|---|---|---|---|
| <b>No</b> | Gutter Cross Slope (%) | <b>9.4</b> | | | |

**Remove & Replace Landing. Remove & Replace Gutter.**

**R304.2.1, R304.5.3, STD 1115**
