# Access Compliance Report Public Rights-of-Way (Curb Ramps)

Main Street: EHLEN\_WAY Cross Street: WARREN\_AVE Location: NE

ADA ID: RPRK220121124240 Ramp Type: Type 4 - Parallel Initial Pass/Fail: Pass Overall Compliance: No Severity Score: 6

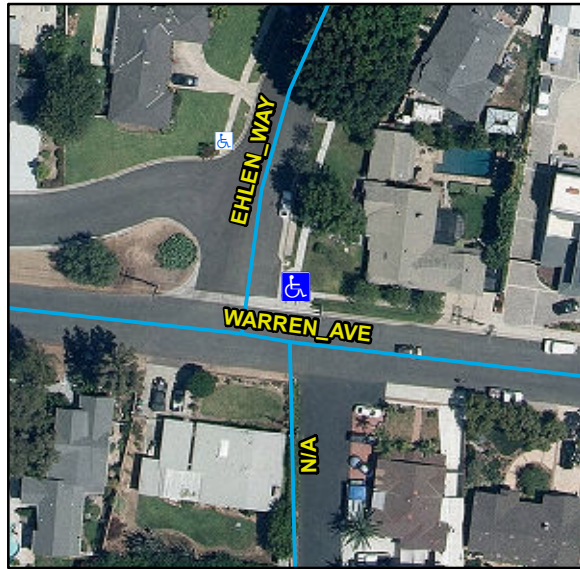
| Compliance | Description | Data | Compliance | Description | Data |
|---|---|---|---|---|---|
| No | Gutter Run Slope (%) | 6.6 | | Road Cross Slope (%) | 6.4 |

Remove & Replace Gutter.

R304.5.4, STD 1115
