# Access Compliance Report Public Rights-of-Way (Curb Ramps)

Main Street: EHLEN\_WAY Cross Street: MANNING\_DR Location: W

ADA ID: RPRK220121124752 Ramp Type: Type 4 - Parallel Initial Pass/Fail: Pass Overall Compliance: No Severity Score: 5

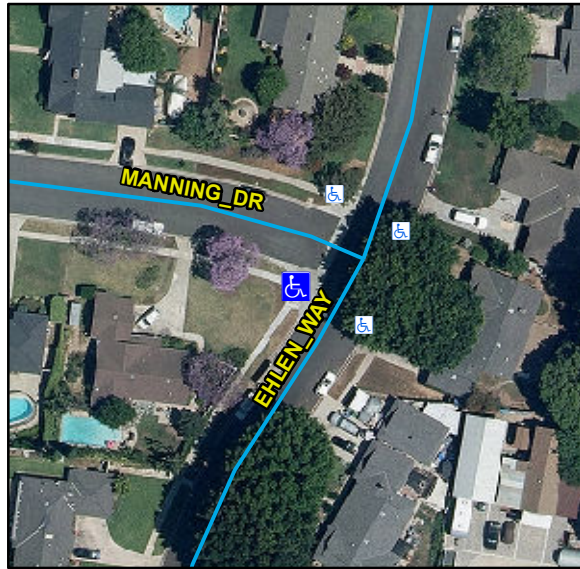
| Compliance | Description | Data | Compliance | Description | Data |
|---|---|---|---|---|---|
| No | Gutter Run Slope (%) | 5.7 | | Road Cross Slope (%) | 3.5 |

Remove & Replace Gutter.

R304.5.4, STD 1115
