Access Compliance Report Public Rights-of-Way (Curb Ramps)

Main Street: PROSPECT AVE **Cross Street: 17TH ST** SW Location:

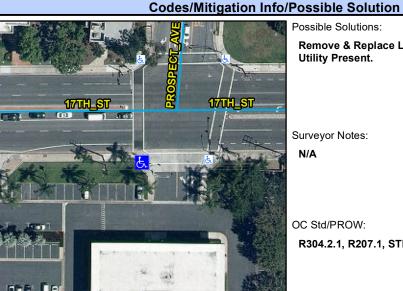
ADA ID: RPRK220124102942 Ramp Type: Type 1 - Perpendicular Diagonal Initial Pass/Fail: Pass **Overall Compliance: No Severity Score:**

Field Measurements/Component Compliance									
	Compliance Description		Data	Compliance Description		Data			
	N/A	Ramp Length (in)	97	N/A	Flare Ty	pe LT			
	Yes	Ramp Width (in)	48				Sloped		
	Yes	Ramp Run Slope (%)	6.3	N/A	Flare Slo	ppe LT (%)	9.3		
	Yes	Ramp Cross Slope (%)	1.1	N/A	Flare Tra	aversable LT	No		
	N/A	Landing Present	Yes	N/A	Flare Ty	pe RT			
	N/A	Landing Length (in)	48				Sloped		
	Yes	Landing Width (in)	48	N/A	Flare Slo	ppe RT (%)	8.2		
	Yes	Landing Run Slope (%)	0.6	N/A	Flare Tra	aversable RT	No		
	Yes	Landing Cross Slope (%)	1.4	Yes	DWS Pr	ovided	Yes		
	N/A	Landing Movement Obstructed?	Yes	Yes	DWS Co	ontrast	Yes		
		Landing Movement Type	Curb	Yes	DWS Le	ngth (in)	36		
	N/A	Landing Shared	No	Yes	DWS Fu	ll Width	Yes		
	Yes	Clear Space	Yes	Yes	DWS Of	fset Left (in)	0		
	Yes	Clear Space To Crosswalk (in)	48	Yes	DWS Of	fset Right (in)	N/A		
1	N/A	Marked Crosswalk 1	Yes	N/A	Marked	Crosswalk 2	Yes

Crossing 1 Direction	Е		Crossing	2 Direction	N		
Ε		Marked Crosswalk 1 Width (in)	144		Marked	Crosswalk 2 Width (in)	144		
al	Yes	Ramp Inside Crosswalk 1	Yes	Yes	Ramp In	side Crosswalk 2	No		
Т		Crossing 1 Slope (%)	0.6		Crossing	g 2 Slope (%)	7.1		
al		Crossing 1 Cross Slope (%)	0.6		Crossing	g 2 Cross Slope (%)	0.5		
	Yes	Gutter Ponding	No	Yes	Curb Slo	рре	1.7		
	Yes	Gutter Lip Height (in)	0		Road R	un Slope (%)	0		
	Yes	Gutter Run Slope (%)	3.5		Road Cr	oss Slope (%)	2.6		
s	Yes	Gutter Cross Slope (%)	0.3						
	Yes	Overall Surface Condition: Acce	ptable	Yes	Perp Joi	nt Present	Yes		
		Cross Gutter Present?	Yes		Spandre	I Present?	Yes		
Х		Replace Cross Gutter?	No		Replace	Spandrel?	No		
	1

Remove & Replace Landing. Restripe Crosswalk. **Utility Present.**

R304.2.1, R207.1, STD 1115
