# Access Compliance Report Public Rights-of-Way (Curb Ramps)

Main Street: PROSPECT\_AVE Cross Street: 17TH\_ST Location: NE

ADA ID: RPRK220124104155 Ramp Type: Type 4 - Parallel Initial Pass/Fail: Pass Overall Compliance: Yes Severity Score: 0

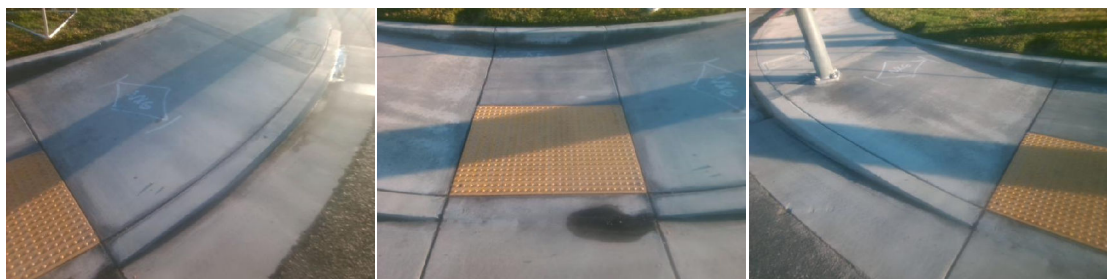
| Compliance | Description | Data | Compliance | Description | Data |
|---|---|---|---|---|---|
| N/A | Ramp Length LT (in) | 100 | N/A | Ramp Length RT (in) | 102 |
| Yes | Ramp Width LT (in) | 80 | Yes | Ramp Width RT (in) | 80 |
| Yes | Ramp Run Slope LT (%) | 8.2 | Yes | Ramp Run Slope RT (%) | 6.1 |
| Yes | Ramp Cross Slope LT (%) | 0.5 | Yes | Ramp Cross Slope RT (%) | 1.9 |
| Yes | Landing Width (in) | 48 | Yes | DWS Length (in) | 36 |
| Yes | Landing Run Slope (%) | 1.2 | Yes | DWS Full Width | Yes |
| Yes | Landing Cross Slope (%) | 0.5 | | DWS Offset Type | Single |
