# Access Compliance Report Public Rights-of-Way (Curb Ramps)

Main Street: HOWLAND\_WAY Cross Street: 17TH\_ST Location: SW

ADA ID: RPRK220124105403 Ramp Type: Type 4 - Parallel Initial Pass/Fail: Pass Overall Compliance: No Severity Score: 5

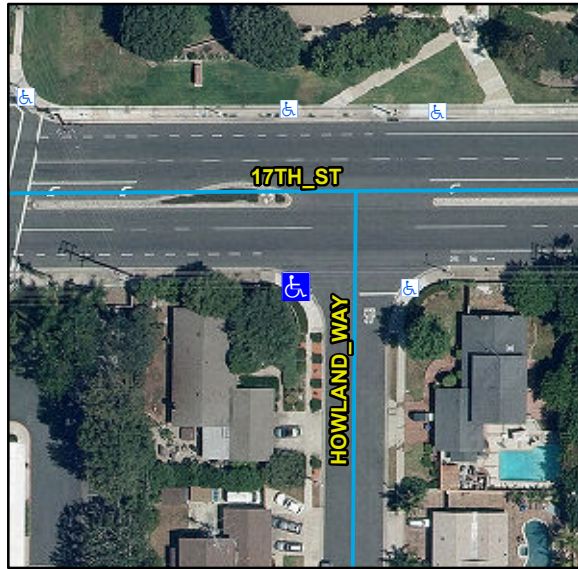
| Compliance | Description | Data | Compliance | Description | Data |
|---|---|---|---|---|---|
| No | Gutter Run Slope (%) | 7.4 | | Road Cross Slope (%) | 3.7 |

Remove & Replace Gutter.

R304.5.4, STD 1115

Total Cost: \$ 252
