# Access Compliance Report Public Rights-of-Way (Curb Ramps)

Main Street: 17TH\_ST Cross Street: HOWLAND\_WAY Location: SE

ADA ID: RPRK220124105737 Ramp Type: Type 4 - Parallel Initial Pass/Fail: Fail Overall Compliance: No Severity Score: 15

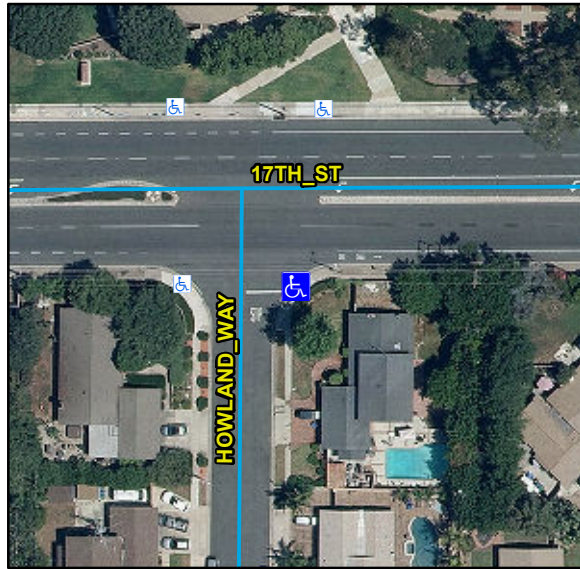
| Compliance | Description | Data | Compliance | Description | Data |
|---|---|---|---|---|---|
| Yes | Ramp Cross Slope LT (%) | 1.2 | No | Ramp Cross Slope RT (%) | 6.3 |

**Remove & Replace Curb Ramp With Two New Directional Ramps or Equivalent.**

**R304.5.3, STD 1115**

Total Cost: \$ 4000
