# Access Compliance Report Public Rights-of-Way (Curb Ramps)

Main Street: DALL\_LN Cross Street: 17TH\_ST Location: NE

ADA ID: RPRK220124112240 Ramp Type: Type 4 - Parallel Initial Pass/Fail: Pass Overall Compliance: No Severity Score: 0

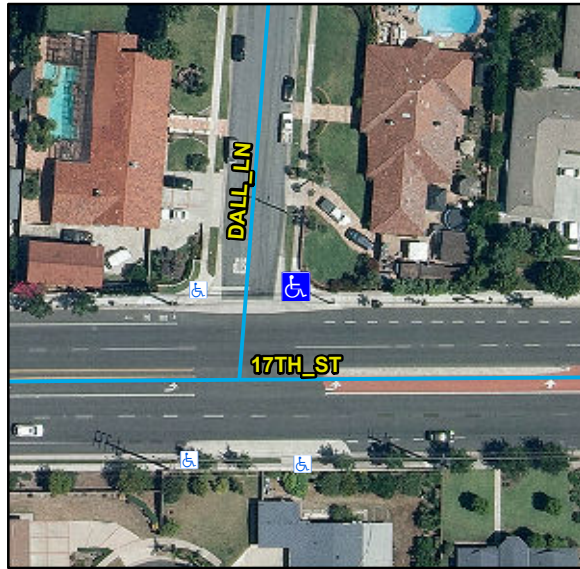
| Compliance | Description | Data | Compliance | Description | Data |
|---|---|---|---|---|---|
| No | Gutter Cross Slope (%) | 5.2 | Yes | Perpendicular Joint Present | Yes |

Possible Solutions:

Remove & Replace Gutter.

OC Std/PROW:

R304.5.3, STD 1115
