# Access Compliance Report Public Rights-of-Way (Curb Ramps)

| Main Street: CHADBOURNE_LN | | Cross Street: JUDY_ANNE_LN | | Location: | SE |
| ADA ID: RPRK220125134720 | Ramp Type: Type 4 - Parallel | Initial Pass/Fail: Fail | Overall Compliance: No | Severity Score: | 15 |

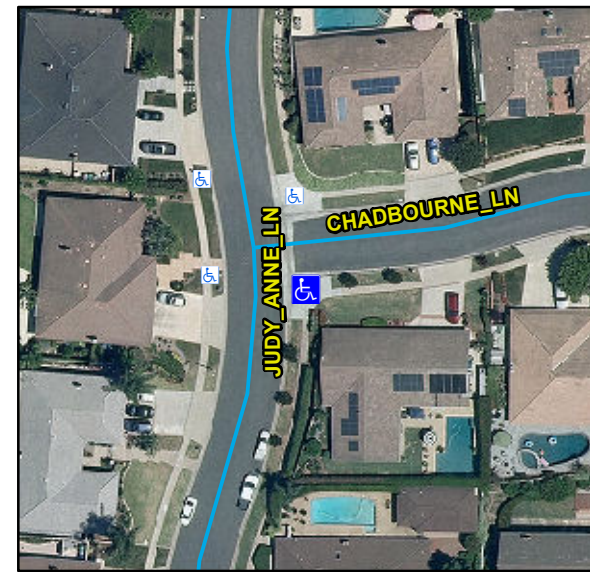
| Compliance | Description | Data | Compliance | Description | Data |
|---|---|---|---|---|---|
| No | Ramp Cross Slope LT (%) | 5.6 | No | Ramp Cross Slope RT (%) | 4.7 |

**Remove & Replace Curb Ramp With Two New Directional Ramps or Equivalent.**

**R304.5.3, STD 1115**

Total Cost: \$ 4000
