# Access Compliance Report Public Rights-of-Way (Curb Ramps)

| Main Street: ROXBOROUGH_DR | | Cross Street: PALM_DR | | Location: | E |
| ADA ID: RPRK220201125826 | Ramp Type: Type 4 - Parallel | Initial Pass/Fail: Pass | Overall Compliance: No | Severity Score: | 5 |

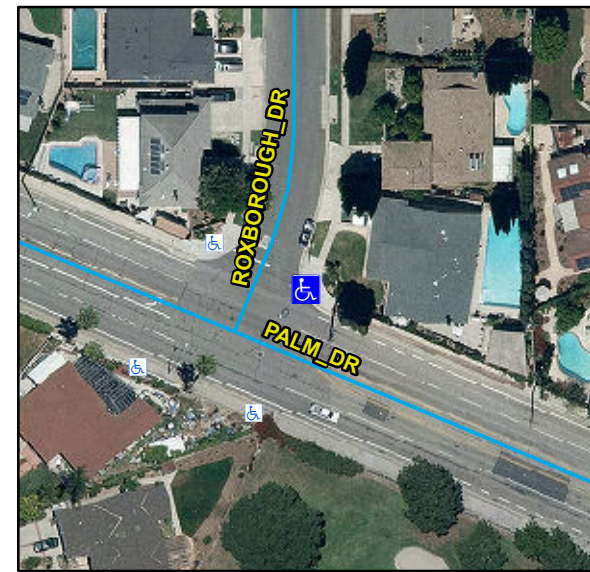
| Compliance | Description | Data | Compliance | Description | Data |
|---|---|---|---|---|---|
| No | Gutter Run Slope (%) | 6.8 | | Road Cross Slope (%) | 1.9 |

Possible Solutions:

Remove & Replace Gutter.

R304.5.4, STD 1115
