# Access Compliance Report Public Rights-of-Way (Curb Ramps)

| Main Street: HAZARD_AVE | | Cross Street: BEACH_BLV | | Location: | S |
| ADA ID: RPRK220202122456 | Ramp Type: Type 4 - Parallel | Initial Pass/Fail: Pass | Overall Compliance: Yes | Severity Score: | 0 |

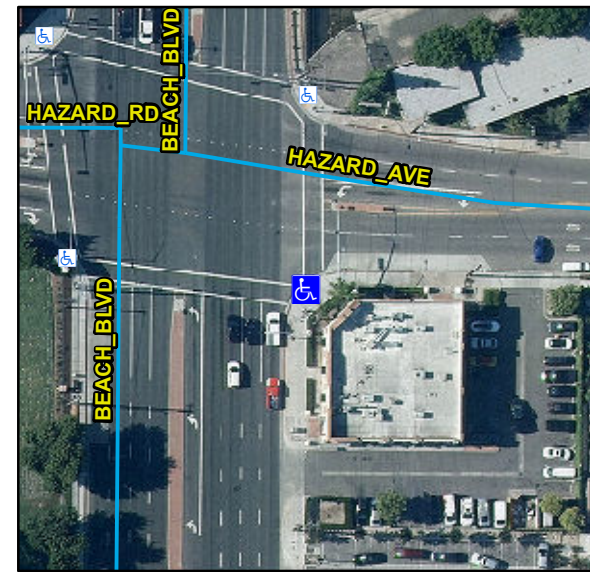
| Compliance | Description | Data | Compliance | Description | Data |
|---|---|---|---|---|---|
| N/A | Ramp Length LT (in) | 113 | N/A | Ramp Length RT (in) | 112 |
| Yes | Ramp Width LT (in) | 145 | Yes | Ramp Width RT (in) | 145 |
| Yes | Ramp Run Slope LT (%) | 2 | Yes | Ramp Run Slope RT (%) | 5.8 |
| Yes | Ramp Cross Slope LT (%) | 0.8 | Yes | Ramp Cross Slope RT (%) | 0.9 |
| Yes | Landing Width (in) | 48 | Yes | DWS Length (in) | 36 |
| Yes | Landing Run Slope (%) | 1.6 | Yes | DWS Full Width | Yes |
| Yes | Landing Cross Slope (%) | 0.5 | | DWS Offset Type | Single |

Possible Solutions:

N/A
