# Access Compliance Report Public Rights-of-Way (Curb Ramps)

Main Street: BEACH\_BLVD Cross Street: HAZARD\_RD Location: SW

ADA ID: RPRK220202123003 Ramp Type: Type 6 - Directional 1 Initial Pass/Fail: Pass Overall Compliance: No Severity Score: 25

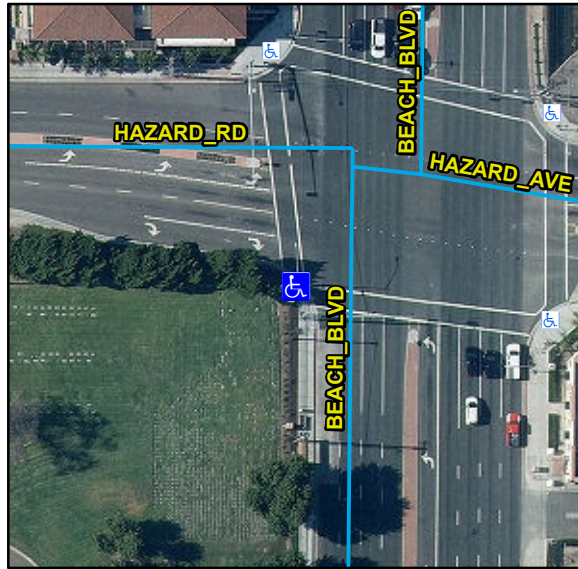
## Obstruction and Utility Measurement/Component Compliance

| Compliance | Description | Data | Compliance | Description | Data |
|---|---|---|---|---|---|
| No | Obstructions Present? | Yes | N/A | Utilities Present? | Yes |
| | Obstruction Types | Traffic Signal Pole | | Utility Types | |

| Compliance | Description | Data | Compliance | Description | Data |
|---|---|---|---|---|---|
| No | Gutter Run Slope (%) | 6.3 | | Road Cross Slope (%) | 2 |
| No | Gutter Cross Slope (%) | 3.1 | | Parallel Ramp Side | Right |

Remove & Replace Curb Ramp With Two New Directional Ramps or Equivalent. Remove & Replace Gutter. Relocate Obstruction. Utility Present.
