# Access Compliance Report

## Public Rights-of-Way

### (Curb Ramps)

Main Street: LEGION\_PL Cross Street: MONROE\_ST Location: NW

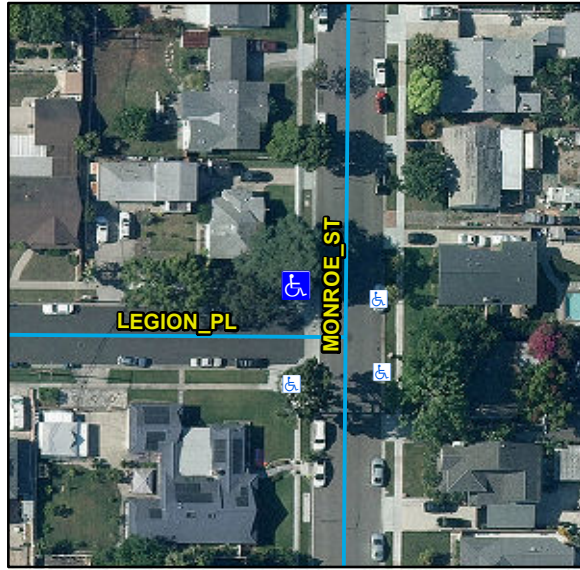
ADA ID: RPRK220202130400 Ramp Type: Type 4 - Parallel Initial Pass/Fail: Pass Overall Compliance: Yes Severity Score: 0

| Compliance | Description | Data | Compliance | Description | Data |
|---|---|---|---|---|---|
| N/A | Ramp Length LT (in) | 91 | N/A | Ramp Length RT (in) | 88 |
| Yes | Ramp Width LT (in) | 110 | Yes | Ramp Width RT (in) | 110 |
| Yes | Ramp Run Slope LT (%) | 5.3 | Yes | Ramp Run Slope RT (%) | 5.1 |
| Yes | Ramp Cross Slope LT (%) | 1.6 | Yes | Ramp Cross Slope RT (%) | 0.5 |
| Yes | Overall Surface Condition | Acceptable | | | |

N/A
