# Access Compliance Report Public Rights-of-Way (Curb Ramps)

Main Street: HAZARD\_AVE Cross Street: MONROE\_ST Location: SE

ADA ID: RPRK220202131054 Ramp Type: Type 4 - Parallel Initial Pass/Fail: Pass Overall Compliance: No Severity Score: 6

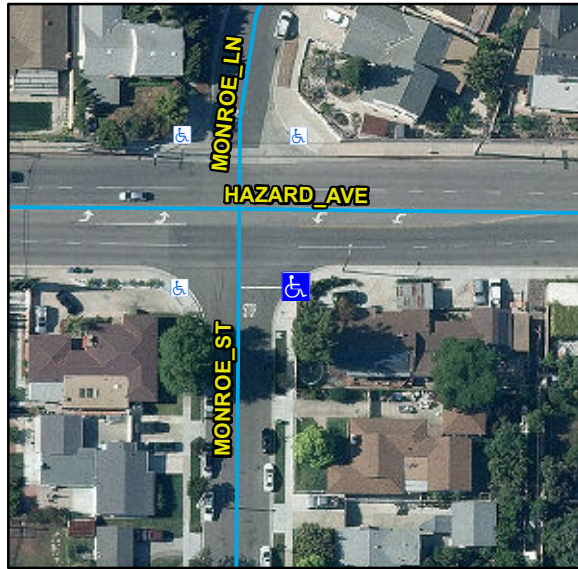
| Compliance | Description | Data | Compliance | Description | Data |
|---|---|---|---|---|---|
| No | Landing Cross Slope (%) | 3 | | DWS Offset Type | Single |
| No | Gutter Ponding | Yes | Yes | Curb Slope | 7.3 |
| No | Gutter Run Slope (%) | 5.5 | | Road Cross Slope (%) | 3 |

Remove & Replace Landing. Remove & Replace Gutter.

R304.5.3, R302.7, R304.5.4, STD 1115
