# Access Compliance Report Public Rights-of-Way (Curb Ramps)

Main Street: BOLSA\_AVE Cross Street: BEACH\_BLV Location: SE

ADA ID: RPRK220202155504 Ramp Type: Type 4 - Parallel Initial Pass/Fail: Pass Overall Compliance: No Severity Score: 5

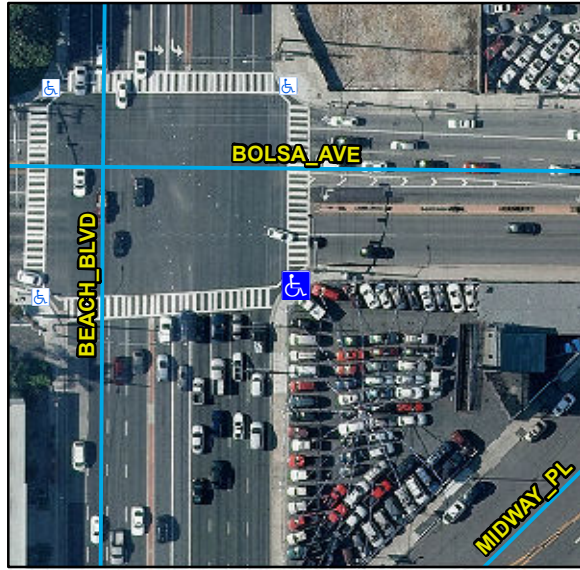
| Compliance | Description | Data | Compliance | Description | Data |
|---|---|---|---|---|---|
| N/A | Landing Length (in) | 80 | No | DWS Contrast | No |

Remove & Replace Detectable Warning System.

R305.1.3, STD 1115

Total Cost: \$ 800
