# Access Compliance Report Public Rights-of-Way (Curb Ramps)

Main Street: HAZARD\_AVE Cross Street: WILSON\_ST Location: NW

ADA ID: RPRK220203113322 Ramp Type: Type 4 - Parallel Initial Pass/Fail: Fail Overall Compliance: No Severity Score: 2

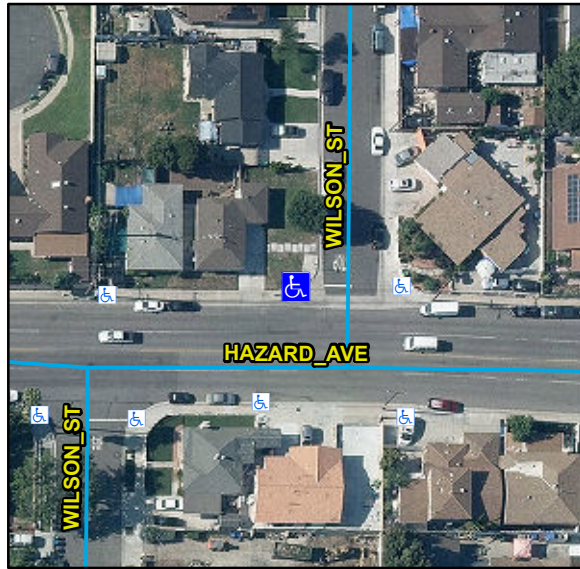
| Compliance | Description | Data | Compliance | Description | Data |
|---|---|---|---|---|---|
| No | Ramp Cross Slope LT (%) | 2.5 | Yes | Ramp Cross Slope RT (%) | 0.3 |

**Remove & Replace Curb Ramp With Two New Directional Ramps or Equivalent.**

**R304.5.3, STD 1115**
