# Access Compliance Report Public Rights-of-Way (Curb Ramps)

Main Street: PURDY\_ST Cross Street: HAZARD\_AVE Location: SW

ADA ID: RPRK220203120820 Ramp Type: Type 4 - Parallel Initial Pass/Fail: Fail Overall Compliance: No Severity Score: 30

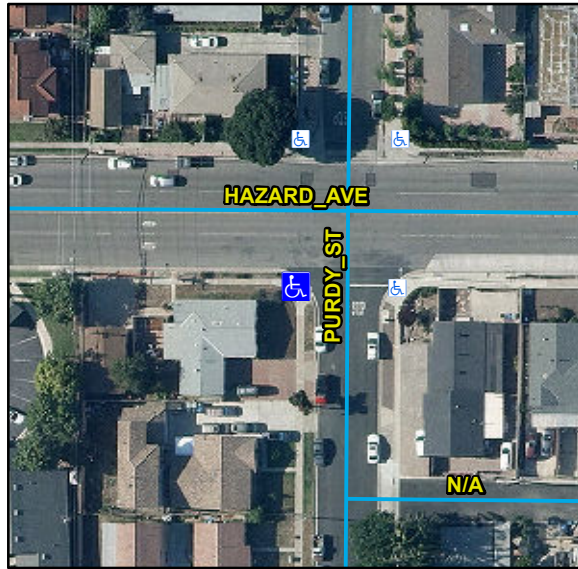
| Compliance | Description | Data | Compliance | Description | Data |
|---|---|---|---|---|---|
| Yes | Ramp Run Slope LT (%) | 4.8 | No | Ramp Run Slope RT (%) | 8.9 |
| No | Ramp Cross Slope LT (%) | 6.5 | No | Ramp Cross Slope RT (%) | 3.7 |

Remove & Replace Curb Ramp With Two New Directional Ramps or Equivalent.
