# Access Compliance Report Public Rights-of-Way (Curb Ramps)

Main Street: HAZARD\_AVE Cross Street: PURDY\_ST Location: SE

ADA ID: RPRK220203121153 Ramp Type: Type 4 - Parallel Initial Pass/Fail: Fail Overall Compliance: No Severity Score: 30

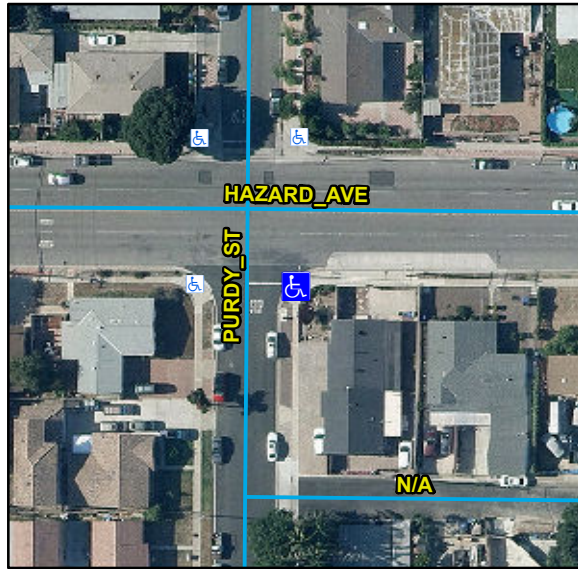
| Compliance | Description | Data | Compliance | Description | Data |
|---|---|---|---|---|---|
| No | Ramp Run Slope LT (%) | 11.1 | Yes | Ramp Run Slope RT (%) | 2.7 |
| No | Ramp Cross Slope LT (%) | 5.6 | No | Ramp Cross Slope RT (%) | 5.3 |

Remove & Replace Curb Ramp With Two New Directional Ramps or Equivalent.

R304.3.2, R304.5.3, STD 1115
