# Access Compliance Report Public Rights-of-Way (Curb Ramps)

Main Street: LANDERS\_DR Cross Street: RIATA\_ST Location: SE

ADA ID: RPRK220203125438 Ramp Type: Type 4 - Parallel Initial Pass/Fail: Pass Overall Compliance: Yes Severity Score: 0

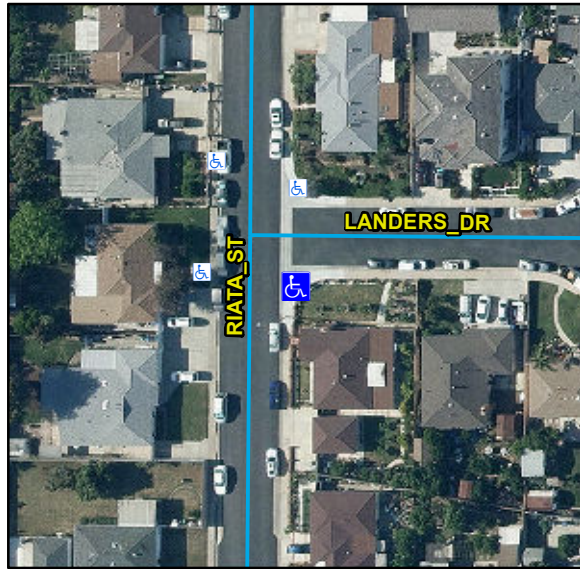
| Compliance | Description | Data | Compliance | Description | Data |
|---|---|---|---|---|---|
| N/A | Ramp Length LT (in) | 82 | N/A | Ramp Length RT (in) | 77 |
| Yes | Ramp Width LT (in) | 61 | Yes | Ramp Width RT (in) | 61 |
| Yes | Ramp Run Slope LT (%) | 8.2 | Yes | Ramp Run Slope RT (%) | 7.9 |
| Yes | Ramp Cross Slope LT (%) | 1.1 | Yes | Ramp Cross Slope RT (%) | 1 |
| Yes | Overall Surface Condition | Acceptable | | | |

Possible Solutions:

N/A
