# Access Compliance Report

## Public Rights-of-Way

Main Street: RIATA\_ST Cross Street: REESE\_WAY Location: NE

ADA ID: RPRK220203132531 Ramp Type: Type 4 - Parallel Initial Pass/Fail: Pass Overall Compliance: Yes Severity Score: 0

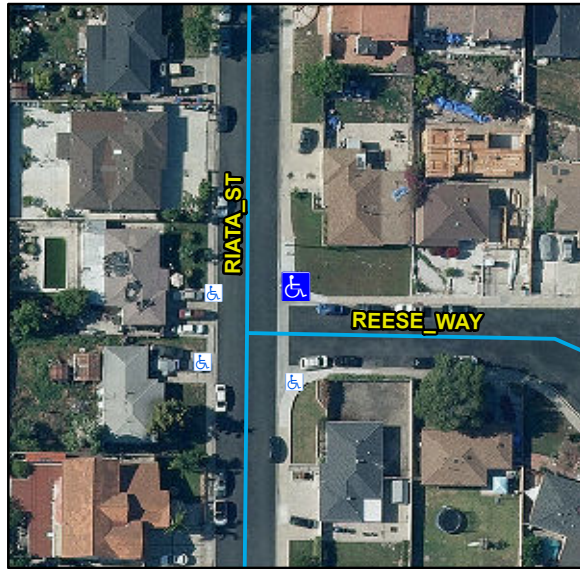
| Compliance | Description | Data | Compliance | Description | Data |
|---|---|---|---|---|---|
| N/A | Ramp Length LT (in) | 78 | N/A | Ramp Length RT (in) | 81 |
| Yes | Ramp Width LT (in) | 58 | Yes | Ramp Width RT (in) | 58 |
| Yes | Ramp Run Slope LT (%) | 6.6 | Yes | Ramp Run Slope RT (%) | 7.1 |
| Yes | Ramp Cross Slope LT (%) | 0.5 | Yes | Ramp Cross Slope RT (%) | 0.3 |
| Yes | Overall Surface Condition | Acceptable | | | |

Possible Solutions:

N/A
