# Access Compliance Report Public Rights-of-Way (Curb Ramps)

| Main Street: REESE_WAY | | Cross Street: RIATA_ST | | Location: | S |
| ADA ID: RPRK220203132853 | Ramp Type: Type 4 - Parallel | Initial Pass/Fail: Pass | Overall Compliance: Yes | Severity Score: | 0 |

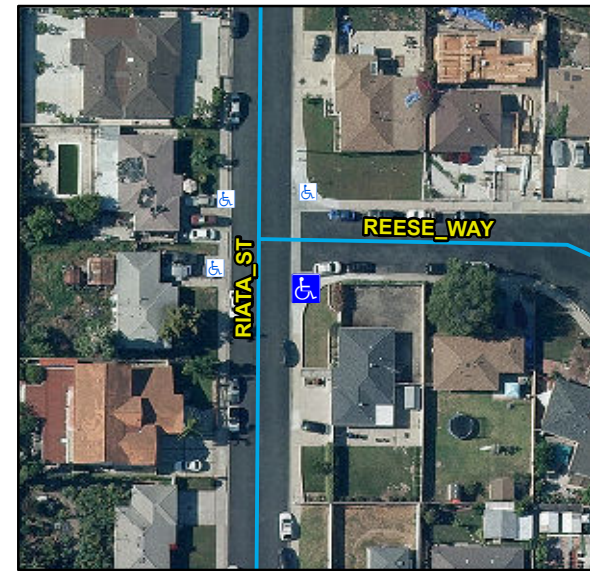
| Compliance | Description | Data | Compliance | Description | Data |
|---|---|---|---|---|---|
| Yes | Ramp Run Slope LT (%) | 7 | Yes | Ramp Run Slope RT (%) | 5.5 |
| Yes | Ramp Cross Slope LT (%) | 1 | Yes | Ramp Cross Slope RT (%) | 1 |

N/A
