# Access Compliance Report Public Rights-of-Way (Curb Ramps)

Main Street: RIATA\_ST Cross Street: BOLSA\_AVE\_FRONTAGE\_ROAD Location: NE

ADA ID: RPRK220203135224 Ramp Type: Type 4 - Parallel Initial Pass/Fail: Pass Overall Compliance: Yes Severity Score: 0

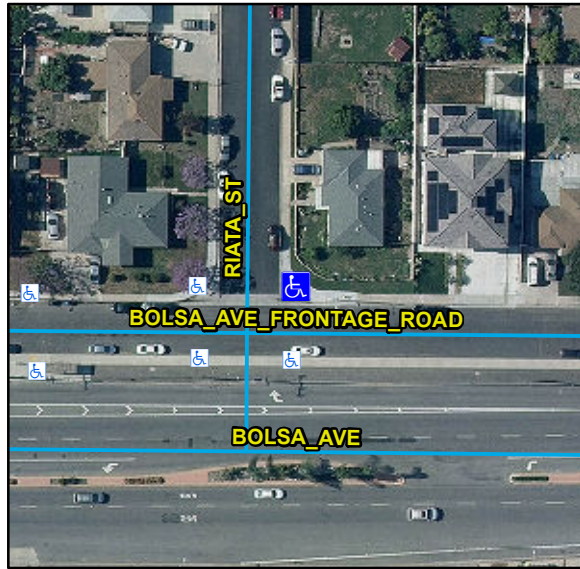
| Compliance | Description | Data | Compliance | Description | Data |
|---|---|---|---|---|---|
| N/A | Ramp Length LT (in) | 88 | N/A | Ramp Length RT (in) | 85 |
| Yes | Ramp Width LT (in) | 74 | Yes | Ramp Width RT (in) | 74 |
| Yes | Ramp Run Slope LT (%) | 7.4 | Yes | Ramp Run Slope RT (%) | 7.6 |
| Yes | Ramp Cross Slope LT (%) | 0.7 | Yes | Ramp Cross Slope RT (%) | 0.5 |
| N/A | Landing Present | Yes | Yes | DWS Provided | Yes |
| N/A | Landing Length (in) | 74 | Yes | DWS Contrast | Yes |
| Yes | Landing Width (in) | 48 | Yes | DWS Length (in) | 36 |
| Yes | Landing Run Slope (%) | 1.6 | Yes | DWS Full Width | Yes |
| Yes | Landing Cross Slope (%) | 0.3 | | DWS Offset Type | Single |
| Yes | Gutter Ponding | No | Yes | Curb Slope | 1.6 |
| Yes | Gutter Lip Height (in) | 0 | | Road Run Slope (%) | 2.6 |
| Yes | Gutter Run Slope (%) | 1.6 | | Road Cross Slope (%) | 2.2 |
| Yes | Gutter Cross Slope (%) | 1.1 | Yes | Perpendicular Joint Present | Yes |
| Yes | Overall Surface Condition | Acceptable | | | |

N/A
