# Access Compliance Report Public Rights-of-Way (Curb Ramps)

Main Street: NEWLAND\_ST Cross Street: BOLSA\_AVE Location: NE

ADA ID: RPRK220203140156 Ramp Type: Type 4 - Parallel Initial Pass/Fail: Pass Overall Compliance: No Severity Score: 6

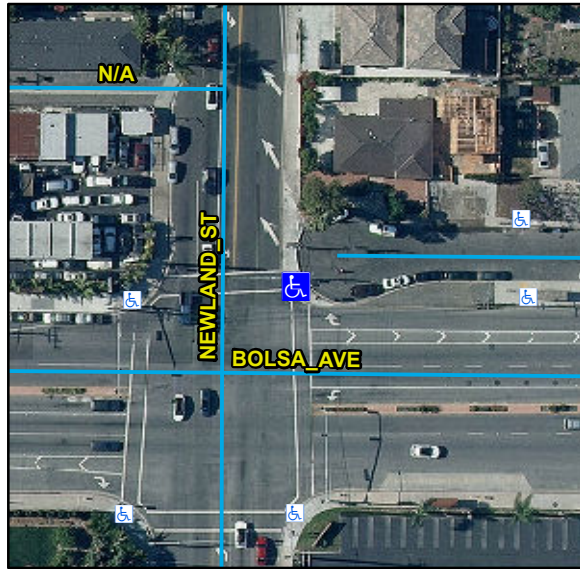
| Compliance | Description | Data | Compliance | Description | Data |
|---|---|---|---|---|---|
| No | Landing Run Slope (%) | 2.7 | No | DWS Full Width | No |
| Yes | Gutter Ponding | No | No | Curb Slope | 9.6 |
| No | Gutter Lip Height (in) | 0.25 | | Road Run Slope (%) | 1.7 |

Remove & Replace Curb Ramp With Two New Directional Ramps or Equivalent. Utility Present.

R304.2.2, R304.2.2-Perp, R304.3.2-Para, R305.1.4, R302.7.2, STD 1115

Total Cost: \$ 4000
