# Access Compliance Report Public Rights-of-Way (Curb Ramps)

Main Street: BOLSA\_AVE\_FRONTAGE\_ROAD Cross Street: PURDY\_ST Location: W

ADA ID: RPRK220203144352 Ramp Type: Type 4 - Parallel Initial Pass/Fail: Fail Overall Compliance: No Severity Score: 4

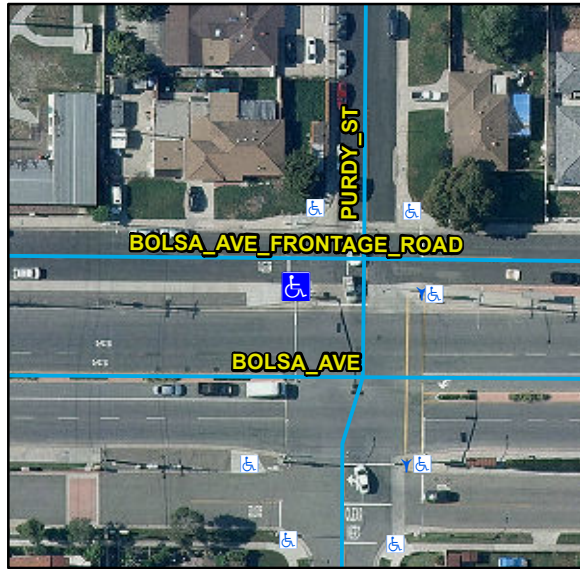
| Compliance | Description | Data | Compliance | Description | Data |
|---|---|---|---|---|---|
| No | Ramp Width LT (in) | 46 | N/A | Ramp Width RT (in) | -9999 |

Remove & Replace Entire Ramp.

R304.5.1, STD 1115
