# Access Compliance Report Public Rights-of-Way (Curb Ramps)

Main Street: BOLSA\_AVE\_FRONTAGE\_ROAD Cross Street: PURDY\_ST Location: NW

ADA ID: RPRK220203144544 Ramp Type: Type 4 - Parallel Initial Pass/Fail: Fail Overall Compliance: No Severity Score: 16

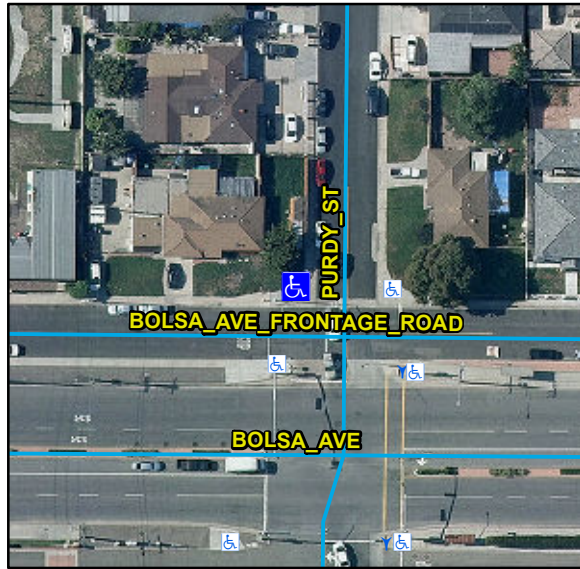
| Compliance | Description | Data | Compliance | Description | Data |
|---|---|---|---|---|---|
| Yes | Ramp Run Slope LT (%) | 6.1 | No | Ramp Run Slope RT (%) | 9.5 |

Remove & Replace Curb Ramp With Two New Directional Ramps or Equivalent.

R304.3.2, STD 1115
