# Access Compliance Report Public Rights-of-Way (Curb Ramps)

Main Street: PURDY\_ST Cross Street: WASHINGTON\_AVE Location: W

ADA ID: RPRK220203150153 Ramp Type: Type 4 - Parallel Initial Pass/Fail: Fail Overall Compliance: No Severity Score: 4

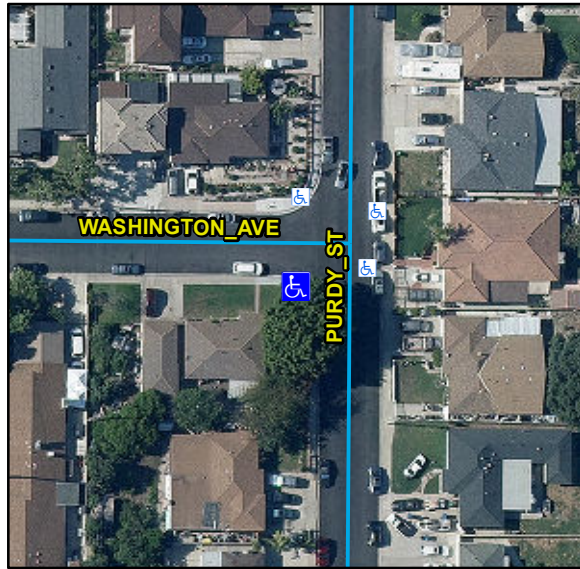
| Compliance | Description | Data | Compliance | Description | Data |
|---|---|---|---|---|---|
| No | Ramp Width LT (in) | 47 | No | Ramp Width RT (in) | 47 |

Remove & Replace Curb Ramp With Two New Directional Ramps or Equivalent.

R304.5.1, STD 1115
