# Access Compliance Report Public Rights-of-Way (Curb Ramps)

Main Street: WASHINGTON\_AVE Cross Street: PURDY\_ST Location: N

ADA ID: RPRK220203150615 Ramp Type: Type 4 - Parallel Initial Pass/Fail: Pass Overall Compliance: No Severity Score: 5

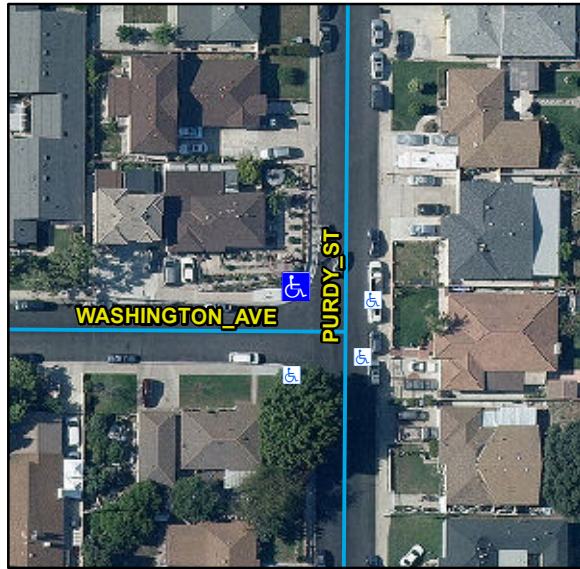
| Compliance | Description | Data | Compliance | Description | Data |
|---|---|---|---|---|---|
| Yes | Gutter Ponding | No | No | Curb Slope | 10.3 |
| No | Gutter Run Slope (%) | 7.3 | | Road Cross Slope (%) | 3.3 |

**Remove & Replace Curb Slope. Remove & Replace Gutter.**

**R304.2.2, R304.5.4, STD 1115**
