# Access Compliance Report Public Rights-of-Way (Curb Ramps)

Main Street: MADISON\_AVE Cross Street: PURDY\_ST Location: SE

ADA ID: RPRK220203151516 Ramp Type: Type 4 - Parallel Initial Pass/Fail: Pass Overall Compliance: No Severity Score: 10

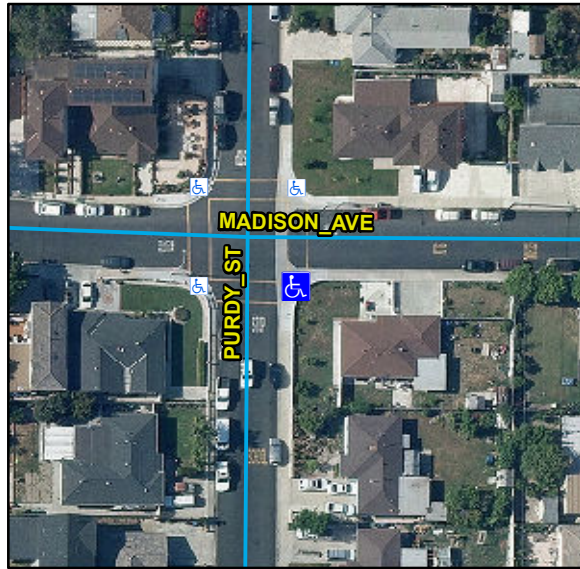
| Compliance | Description | Data | Compliance | Description | Data |
|---|---|---|---|---|---|
| Yes | Gutter Ponding | No | No | Curb Slope | 9.4 |
| No | Gutter Lip Height (in) | 1.5 | | Road Run Slope (%) | 1.1 |

Remove & Replace Curb Slope.

R304.2.2, R302.7.2, STD 1115
