# Access Compliance Report Public Rights-of-Way (Curb Ramps)

Main Street: MADISON\_AVE Cross Street: HUNTER\_LN Location: SE

ADA ID: RPRK220203152247 Ramp Type: Type 4 - Parallel Initial Pass/Fail: Pass Overall Compliance: No Severity Score: 5

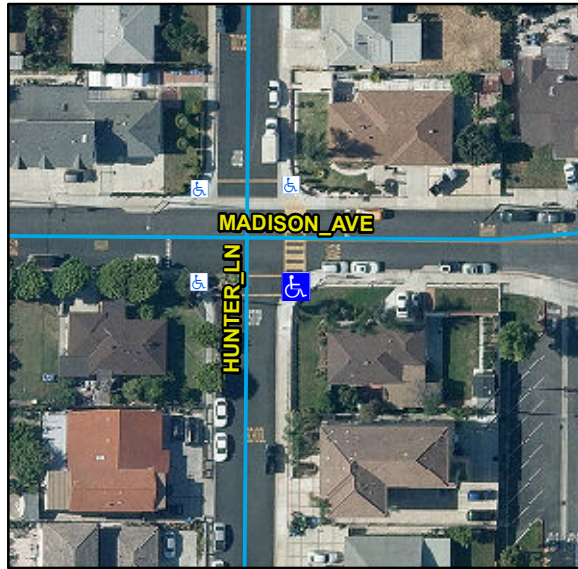
| Compliance | Description | Data | Compliance | Description | Data |
|---|---|---|---|---|---|
| No | Gutter Run Slope (%) | 10.6 | | Road Cross Slope (%) | 4.4 |

Remove & Replace Gutter.

R304.5.4, STD 1115
