# Access Compliance Report Public Rights-of-Way (Curb Ramps)

| Main Street: MADISON_AVE | | Cross Street: HUNTER_LN | | Location: | NW |
| ADA ID: RPRK220203152951 | Ramp Type: Type 4 - Parallel | Initial Pass/Fail: Pass | Overall Compliance: No | Severity Score: | 0 |

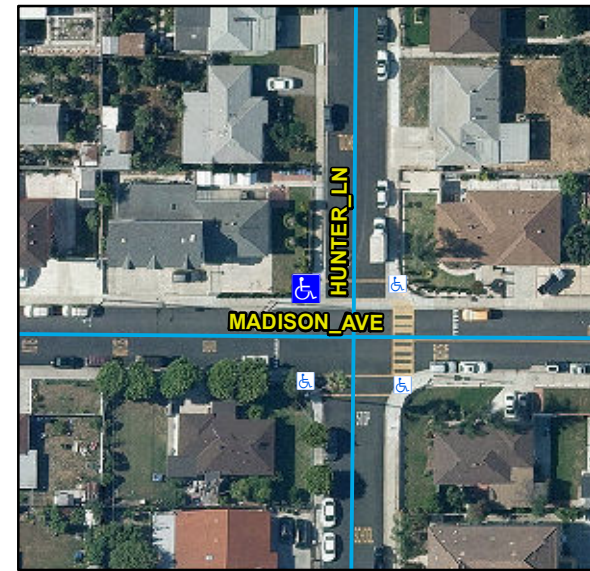
| Compliance | Description | Data | Compliance | Description | Data |
|---|---|---|---|---|---|
| No | Landing Run Slope (%) | 2.2 | Yes | DWS Full Width | Yes |

**Remove & Replace Landing.**

**R304.2.2-Perp, R304.3.2-Para, STD 1115**

Total Cost: \$ 531
