# Access Compliance Report Public Rights-of-Way (Curb Ramps)

Main Street: MADISON\_AVE Cross Street: PURDY\_ST Location: NW

ADA ID: RPRK220203153612 Ramp Type: Type 4 - Parallel Initial Pass/Fail: Pass Overall Compliance: No Severity Score: 5

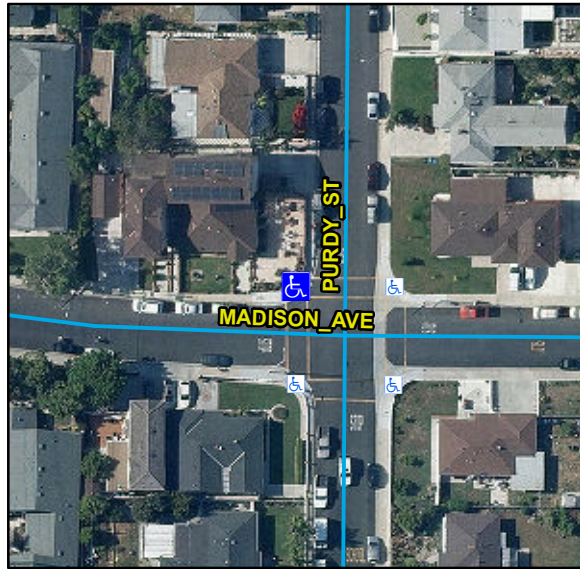
| Compliance | Description | Data | Compliance | Description | Data |
|---|---|---|---|---|---|
| No | Gutter Run Slope (%) | 6.9 | | Road Cross Slope (%) | 3.7 |

Remove & Replace Gutter.

R304.5.4, STD 1115
