# Access Compliance Report Public Rights-of-Way (Curb Ramps)

Main Street: HUNTER\_LN Cross Street: ROOSEVELT\_AVE Location: SW

ADA ID: RPRK220203154516 Ramp Type: Type 4 - Parallel Initial Pass/Fail: Pass Overall Compliance: No Severity Score: 5

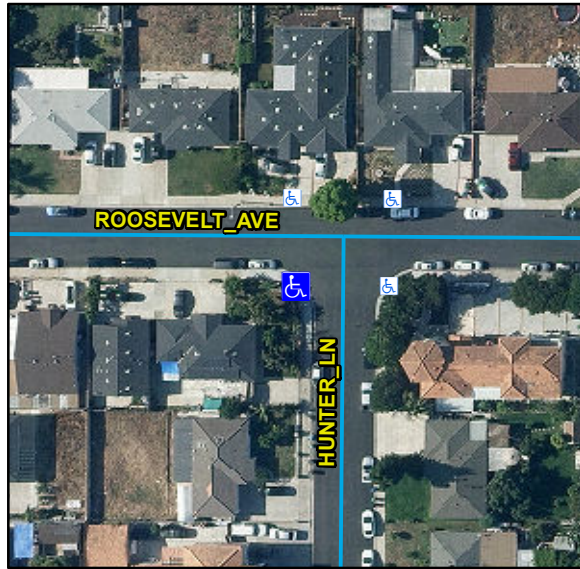
| Compliance | Description | Data | Compliance | Description | Data |
|---|---|---|---|---|---|
| No | Gutter Run Slope (%) | 6.5 | | Road Cross Slope (%) | 3.1 |

Remove & Replace Gutter.

R304.5.4, STD 1115
