# Access Compliance Report Public Rights-of-Way (Curb Ramps)

Main Street: N/A Cross Street: BEACH\_BLV Location: N

ADA ID: RPRK220203163051 Ramp Type: Type 7 - Directional 2 Initial Pass/Fail: Pass Overall Compliance: No Severity Score: 0

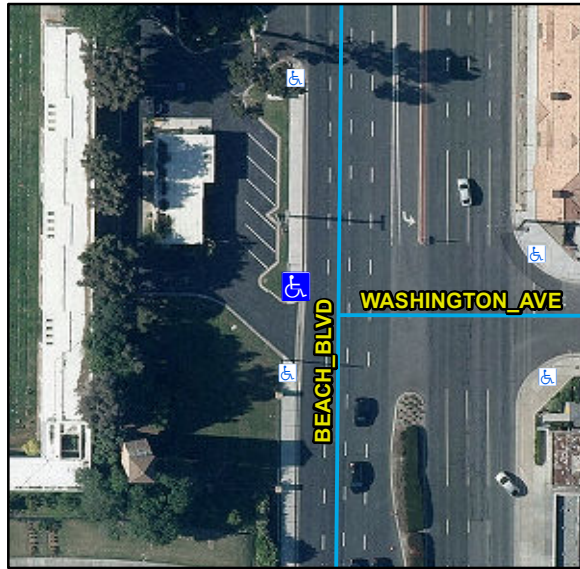
| Compliance | Description | Data | Compliance | Description | Data |
|---|---|---|---|---|---|
| Yes | Landing Cross Slope (%) | 2.7 | No | DWS Left Offset (in) | 30 |

Remove & Replace Detectable Warning System.

R305.2, STD 1115

\$ 800
