# Access Compliance Report Public Rights-of-Way (Curb Ramps)

Main Street: DANA\_POINT\_HARBOR\_DR Cross Street: PUERTO\_PL Location: SW

ADA ID: RPRK220208145246 Ramp Type: Type 1 - Perpendicular Diagonal Initial Pass/Fail: Pass Overall Compliance: No Severity Score: 2

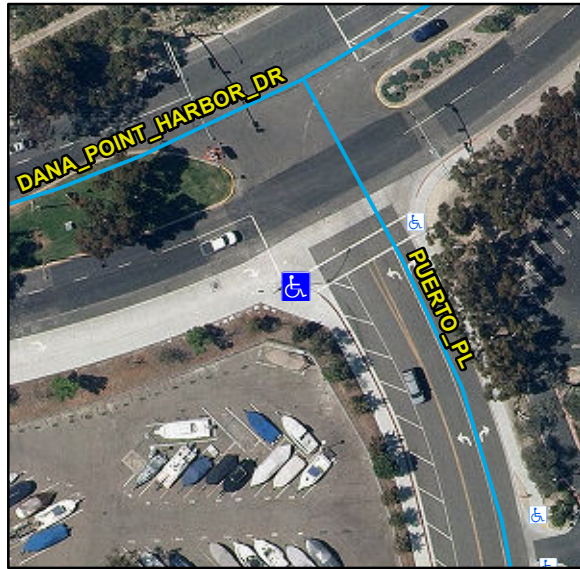
## Field Measurements/Component Compliance

Remove & Replace Curb Ramp With Two New Directional Ramps or Equivalent.

R304.2.3, STD 1115
