# Access Compliance Report Public Rights-of-Way (Curb Ramps)

Main Street: PUERTO\_PL Cross Street: N/A Location: SW

ADA ID: RPRK220208151914 Ramp Type: Type 1 - Perpendicular Diagonal Initial Pass/Fail: Pass Overall Compliance: No Severity Score: 12

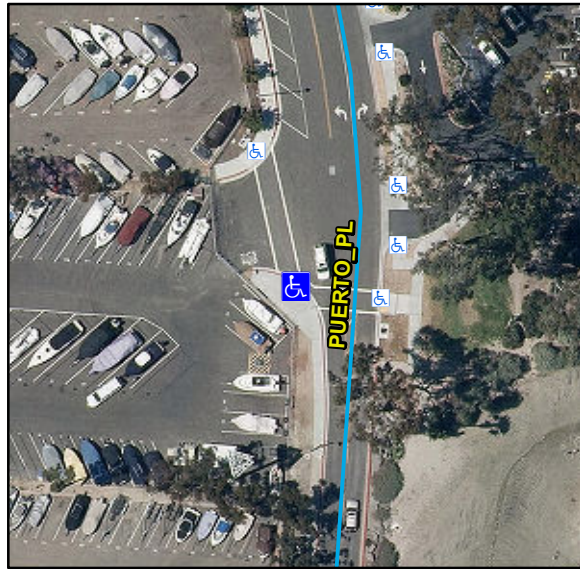
| Compliance | Description | Data | Compliance | Description | Data |
|---|---|---|---|---|---|
| N/A | Ramp Length (in) | 130 | No | Flare Type LT | |
| N/A | Landing Present | Yes | No | Flare Type RT | |
| Yes | Landing Cross Slope (%) | 2 | No | DWS Provided | No |

**Remove & Replace Curb Ramp With Two New Directional Ramps or Equivalent.**

**R304.2.1, R304.2.3, R305, STD 1115**
