# Access Compliance Report Public Rights-of-Way (Curb Ramps)

Main Street: DONNIS\_RD Cross Street: DONNIE\_ANN\_RD Location: NE

ADA ID: RPRK220217185204 Ramp Type: Type 1 - Perpendicular Diagonal Initial Pass/Fail: Pass Overall Compliance: No Severity Score: 16

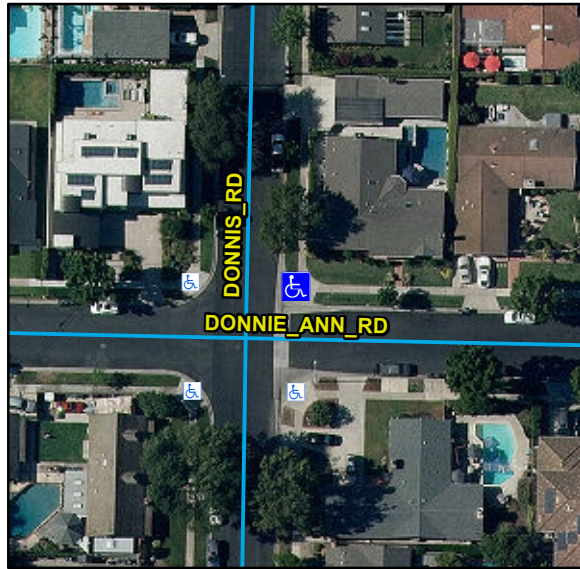
| Compliance | Description | Data | Compliance | Description | Data |
|---|---|---|---|---|---|
| No | Landing Run Slope (%) | 3.1 | N/A | Flare Traversable RT | No |
| Yes | Landing Cross Slope (%) | 0.2 | No | DWS Provided | No |

Remove & Replace Curb Ramp With Two New Directional Ramps or Equivalent.
