# Access Compliance Report Public Rights-of-Way (Curb Ramps)

Main Street: DONNIS\_RD Cross Street: RUTH\_ELAINE\_DR Location: SW

ADA ID: RPRK220217191314 Ramp Type: Type 1 - Perpendicular Diagonal Initial Pass/Fail: Pass Overall Compliance: No Severity Score: 10

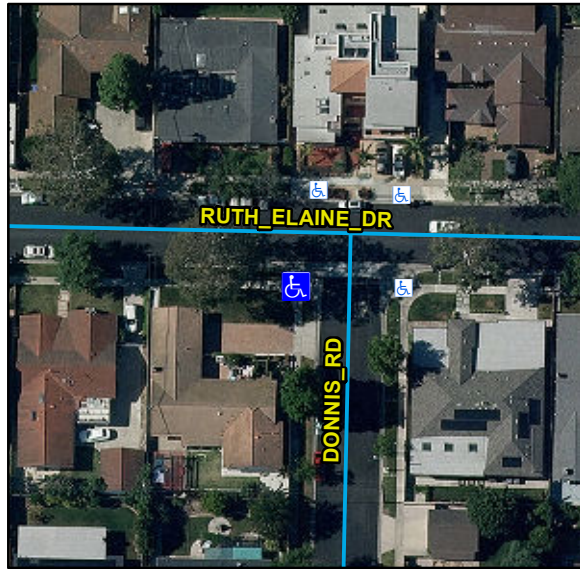
| Compliance | Description | Data | Compliance | Description | Data |
|---|---|---|---|---|---|
| No | Landing Run Slope (%) | 2.6 | N/A | Flare Traversable RT | No |
| Yes | Landing Cross Slope (%) | 0 | No | DWS Provided | No |

Remove & Replace Curb Ramp With Two New Directional Ramps or Equivalent.
