# Access Compliance Report

## Public Rights-of-Way

### (Curb Ramps)

Main Street: **ORANGE\_AVE** Cross Street: **S\_BROOKHURST\_ST** Location: **SE**

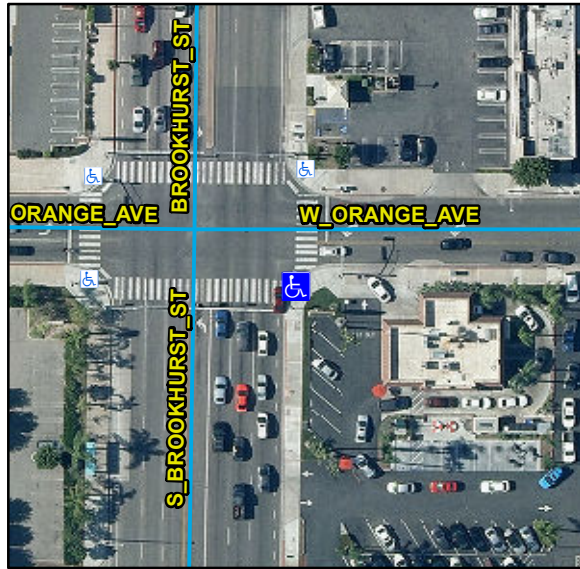
ADA ID: **RPRK220218195300** Ramp Type: **Type 4 - Parallel** Initial Pass/Fail: **Pass** Overall Compliance: **No** Severity Score: **10**

| Compliance | Description | Data | Compliance | Description | Data |
|---|---|---|---|---|---|
| <b>Yes</b> | Landing Run Slope (%) | <b>1.4</b> | <b>No</b> | DWS Full Width | <b>No</b> |
| <b>N/A</b> | Landing Movement Obstructed? | <b>No</b> | <b>No</b> | DWS Offset Left (in) | <b>4</b> |
| <b>No</b> | Gutter Run Slope (%) | <b>12.6</b> | | Road Cross Slope (%) | <b>0.5</b> |

Possible Solutions:

**Remove & Replace Detectable Warning System.  
Remove & Replace Gutter.**

**R305.1.4, R305.2, R304.5.4, STD 1115**

Total Cost: \$ **1052**
