# Access Compliance Report Public Rights-of-Way (Curb Ramps)

Main Street: MILLS\_END Cross Street: ORANGE\_AVE Location: SW

ADA ID: RPRK220218200853 Ramp Type: Type 4 - Parallel Initial Pass/Fail: Pass Overall Compliance: No Severity Score: 0

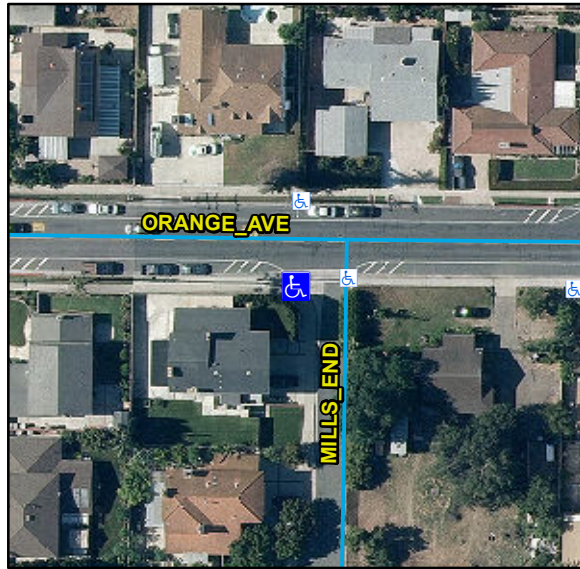
| Compliance | Description | Data | Compliance | Description | Data |
|---|---|---|---|---|---|
| No | Landing Run Slope (%) | 2.3 | Yes | DWS Full Width | Yes |

Remove & Replace Landing.
