# Access Compliance Report Public Rights-of-Way (Curb Ramps)

Main Street: N/A Cross Street: PACIFIC\_AVE Location: NE

ADA ID: RPRK220221122622 Ramp Type: Type 7 - Directional 2 Initial Pass/Fail: Pass Overall Compliance: No Severity Score: 7

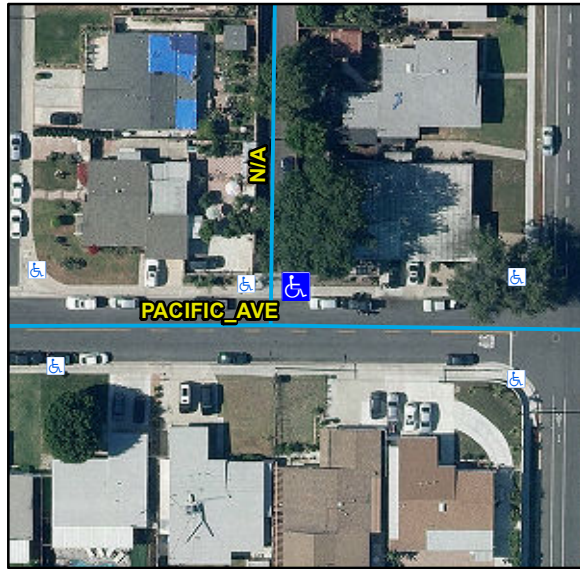
| Compliance | Description | Data | Compliance | Description | Data |
|---|---|---|---|---|---|
| Yes | Landing Width (in) | 53 | No | DWS Full Width | No |
| No | Landing Cross Slope (%) | 2.6 | Yes | DWS Left Offset (in) | 12 |

Possible Solutions:

Remove & Replace Entire Ramp.

R304.5.3, R305.1.4, STD 1115
