# Access Compliance Report Public Rights-of-Way (Curb Ramps)

Main Street: N/A Cross Street: PACIFIC\_AVE Location: NW

ADA ID: RPRK220221123007 Ramp Type: Type 7 - Directional 2 Initial Pass/Fail: Pass Overall Compliance: No Severity Score: 7

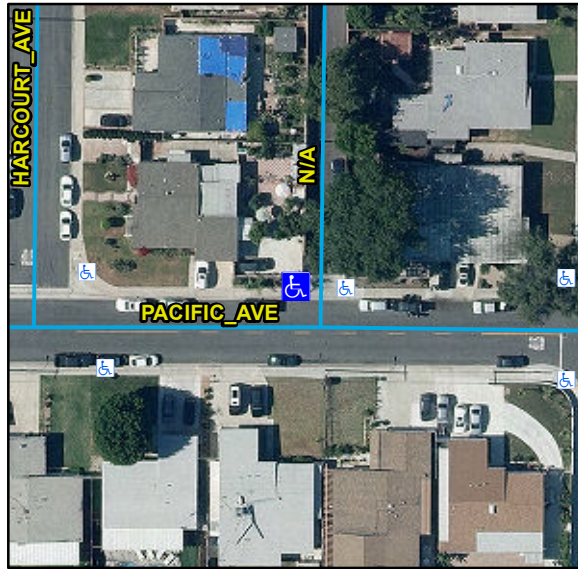
| Compliance | Description | Data | Compliance | Description | Data |
|---|---|---|---|---|---|
| Yes | Landing Width (in) | 55 | No | DWS Full Width | No |
| No | Landing Cross Slope (%) | 3.1 | Yes | DWS Left Offset (in) | 0 |

Remove & Replace Entire Ramp.

R304.5.3, R305.1.4, STD 1115

Total Cost: \$ 3080
