# Access Compliance Report Public Rights-of-Way (Curb Ramps)

Main Street: **S\_BROOKHURST\_ST** Cross Street: **W\_CRESTWOOD\_LN** Location: **NE**

ADA ID: **RPRK220221123759** Ramp Type: **Type 6 - Directional 1** Initial Pass/Fail: **Pass** Overall Compliance: **No** Severity Score: **0**

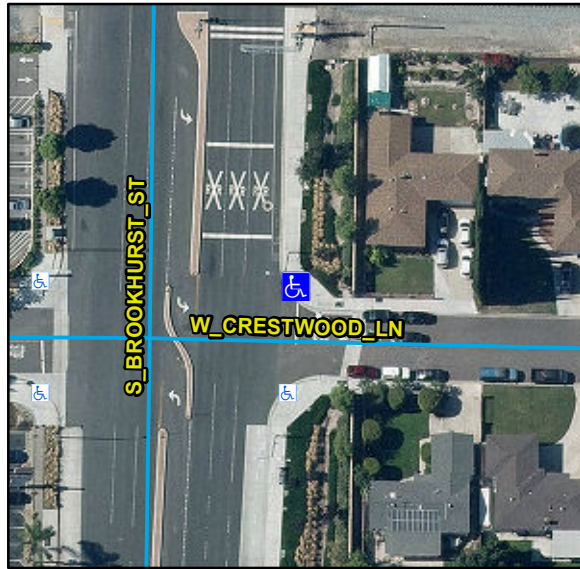
| Compliance | Description | Data | Compliance | Description | Data |
|---|---|---|---|---|---|
| <b>No</b> | Landing Run Slope (%) | <b>2.1</b> | | DWS Offset Type | <b>Single</b> |

**Remove & Replace Landing.**

**R304.2.2-Perp, R304.3.2-Para, STD 1115**
