Access Compliance Report Public Rights-of-Way (Curb Ramps)

Main Street: DANA_DR **Cross Street:** DANA_DR **Location:** S

ADA ID: RPRK220221162114 **Ramp Type:** Type 4 - Parallel **Initial Pass/Fail:** Pass **Overall Compliance:** Yes **Severity Score:** 0

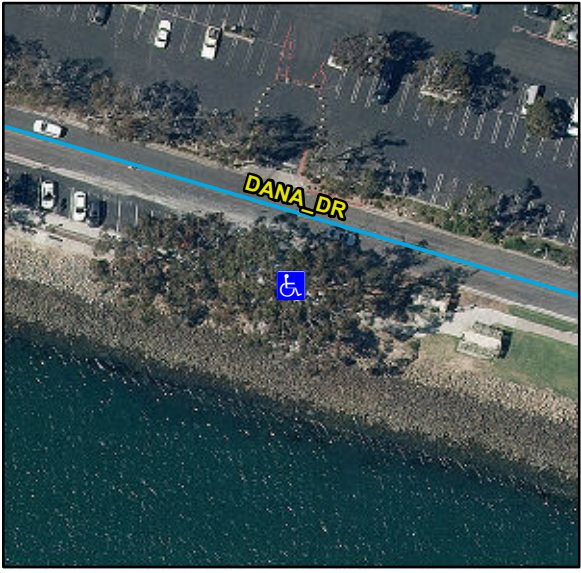
Compliance	Description	Data	Compliance	Description	Data
N/A	Ramp Length LT (in)	103	N/A	Ramp Length RT (in)	109
Yes	Ramp Width LT (in)	66	Yes	Ramp Width RT (in)	66
Yes	Ramp Run Slope LT (%)	2.3	Yes	Ramp Run Slope RT (%)	3.2
Yes	Ramp Cross Slope LT (%)	1	Yes	Ramp Cross Slope RT (%)	1.9
N/A	Landing Present	Yes	Yes	DWS Provided	Yes
N/A	Landing Length (in)	66	Yes	DWS Contrast	Yes
Yes	Landing Width (in)	48	Yes	DWS Length (in)	36
Yes	Landing Run Slope (%)	1.1	Yes	DWS Full Width	Yes
Yes	Landing Cross Slope (%)	0.4		DWS Offset Type	Single
N/A	Landing Movement Obstructed?	No	Yes	DWS Offset Left (in)	0
	Landing Movement Type	Curb	Yes	DWS Offset Right (in)	N/A
N/A	Landing Shared	No			
N/A	Clear Space	N/A			
N/A	Clear Space To Crosswalk (in)	N/A			
N/A	Marked Crosswalk 1	No	N/A	Marked Crosswalk 2	N/A
	Crossing 1 Direction	N		Crossing 2 Direction	N/A
	Marked Crosswalk 1 Width (in)	N/A		Marked Crosswalk 2 Width (in)	N/A

N/A	Ramp Inside Crosswalk 1	N/A	N/A	Ramp Inside Crosswalk 2	N/A
	Crossing 1 Slope (%)	1		Crossing 2 Slope (%)	N/A
	Crossing 1 Cross Slope (%)	0.1		Crossing 2 Cross Slope (%)	N/A
Yes	Gutter Ponding	No	Yes	Curb Slope	0.9
Yes	Gutter Lip Height (in)	0		Road Run Slope (%)	N/A
Yes	Gutter Run Slope (%)	0.7		Road Cross Slope (%)	N/A
Yes	Gutter Cross Slope (%)	0.1	Yes	Perpendicular Joint Present	Yes
Yes	Overall Surface Condition	Acceptable			
	Cross Gutter Present?	No		Spandrel Present?	No
	Replace Cross Gutter?	N/A		Replace Spandrel?	N/A

Possible Solutions:
N/A
